4TH FLOOR BOILER HOUSE SECTION VII ROOM 7.06 G

**Non-TCRA Building Assessment
Avtex Fibers Superfund Site**

POLYESTER SPINNING FOURTH FLOOR SECTION 1

POLYMER PLANT 4TH FLOOR SECTION 1 ROOM 1.05 E

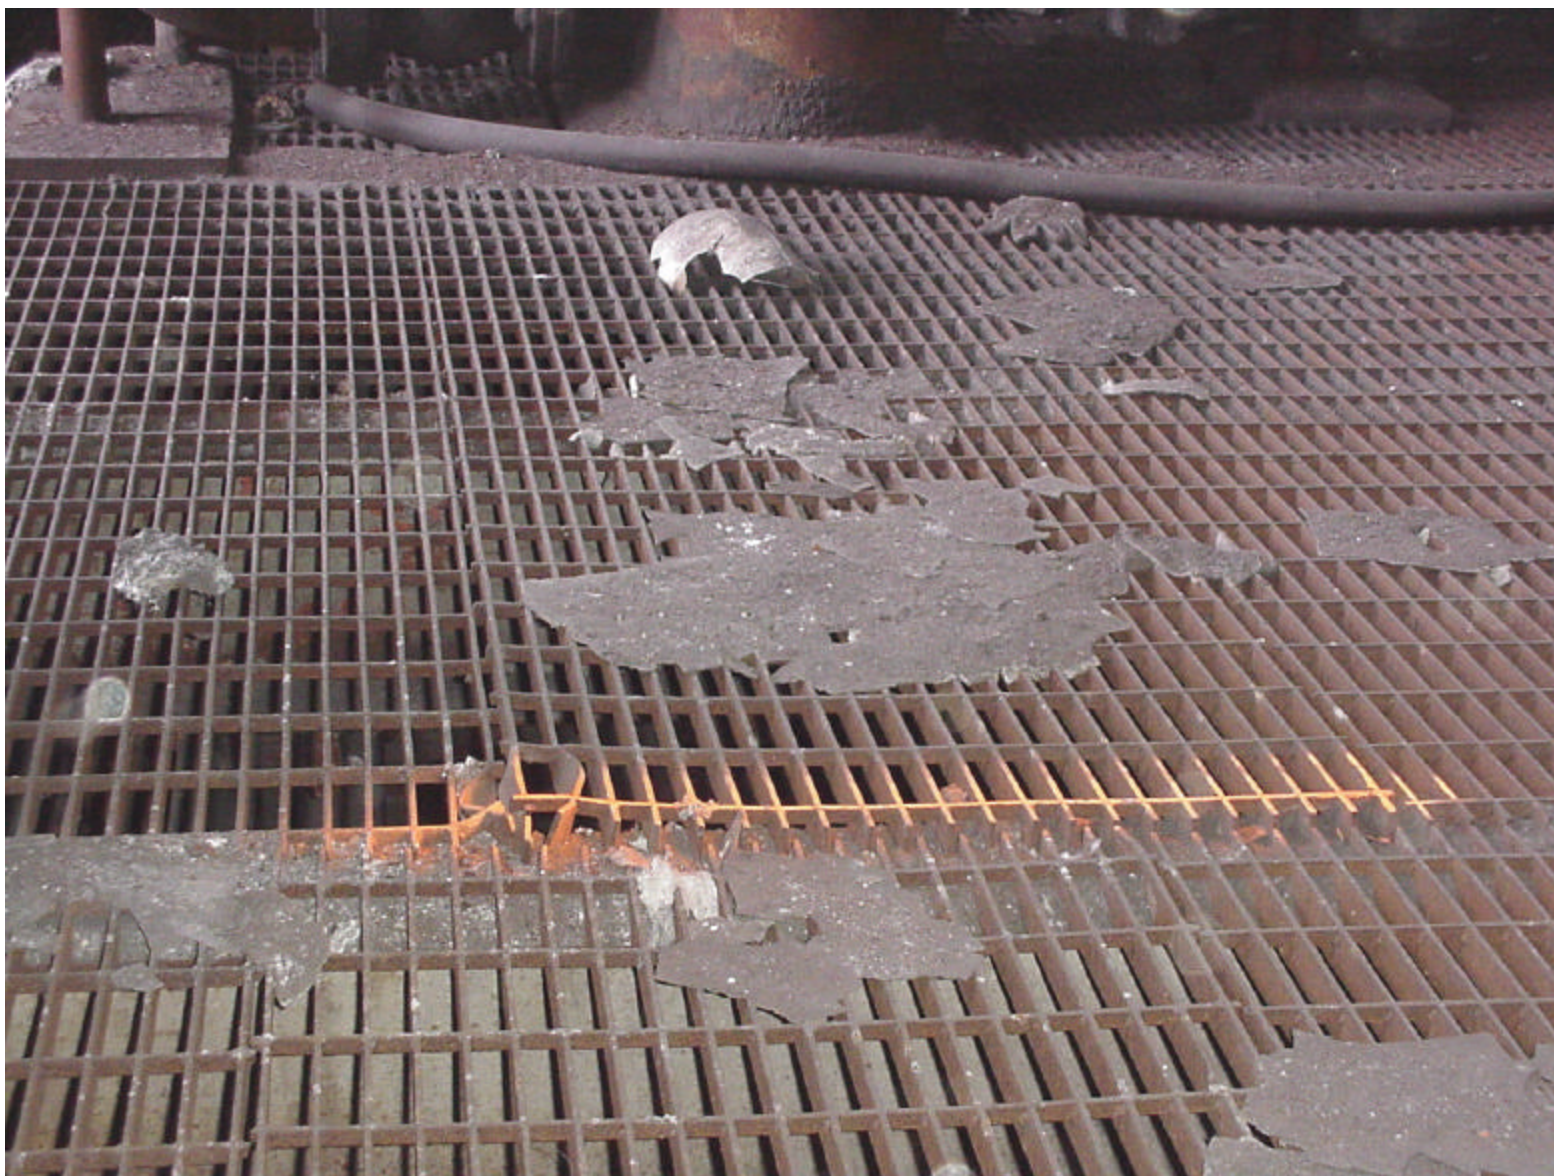
Photograph ID	Date Taken	Section #	Room #	Room Description	Description
MVC-692		VII	7.06G	4nd Floor Boiler House	Buckeled steel floor grate in northwest corner of room

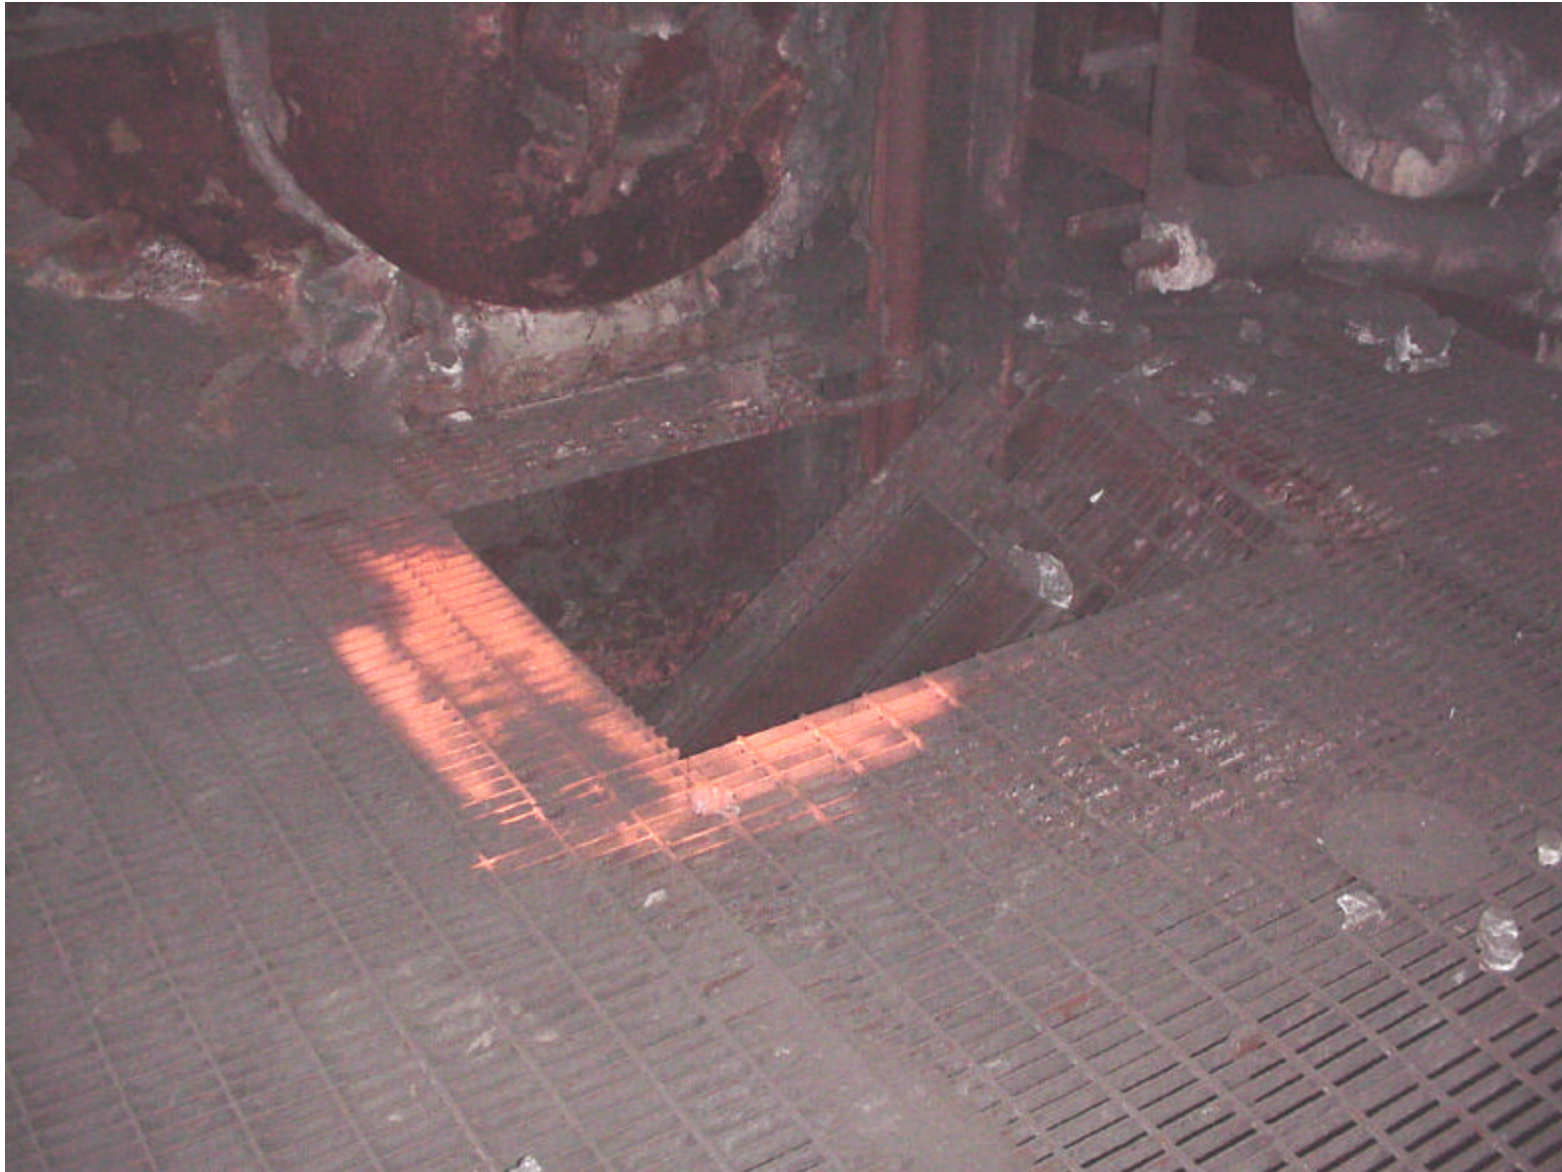
Photograph ID	Date Taken	Section #	Room #	Room Description	Description
MVC-695		VII	7.06G	4nd Floor Boiler House	Missing floor grate in middle of room

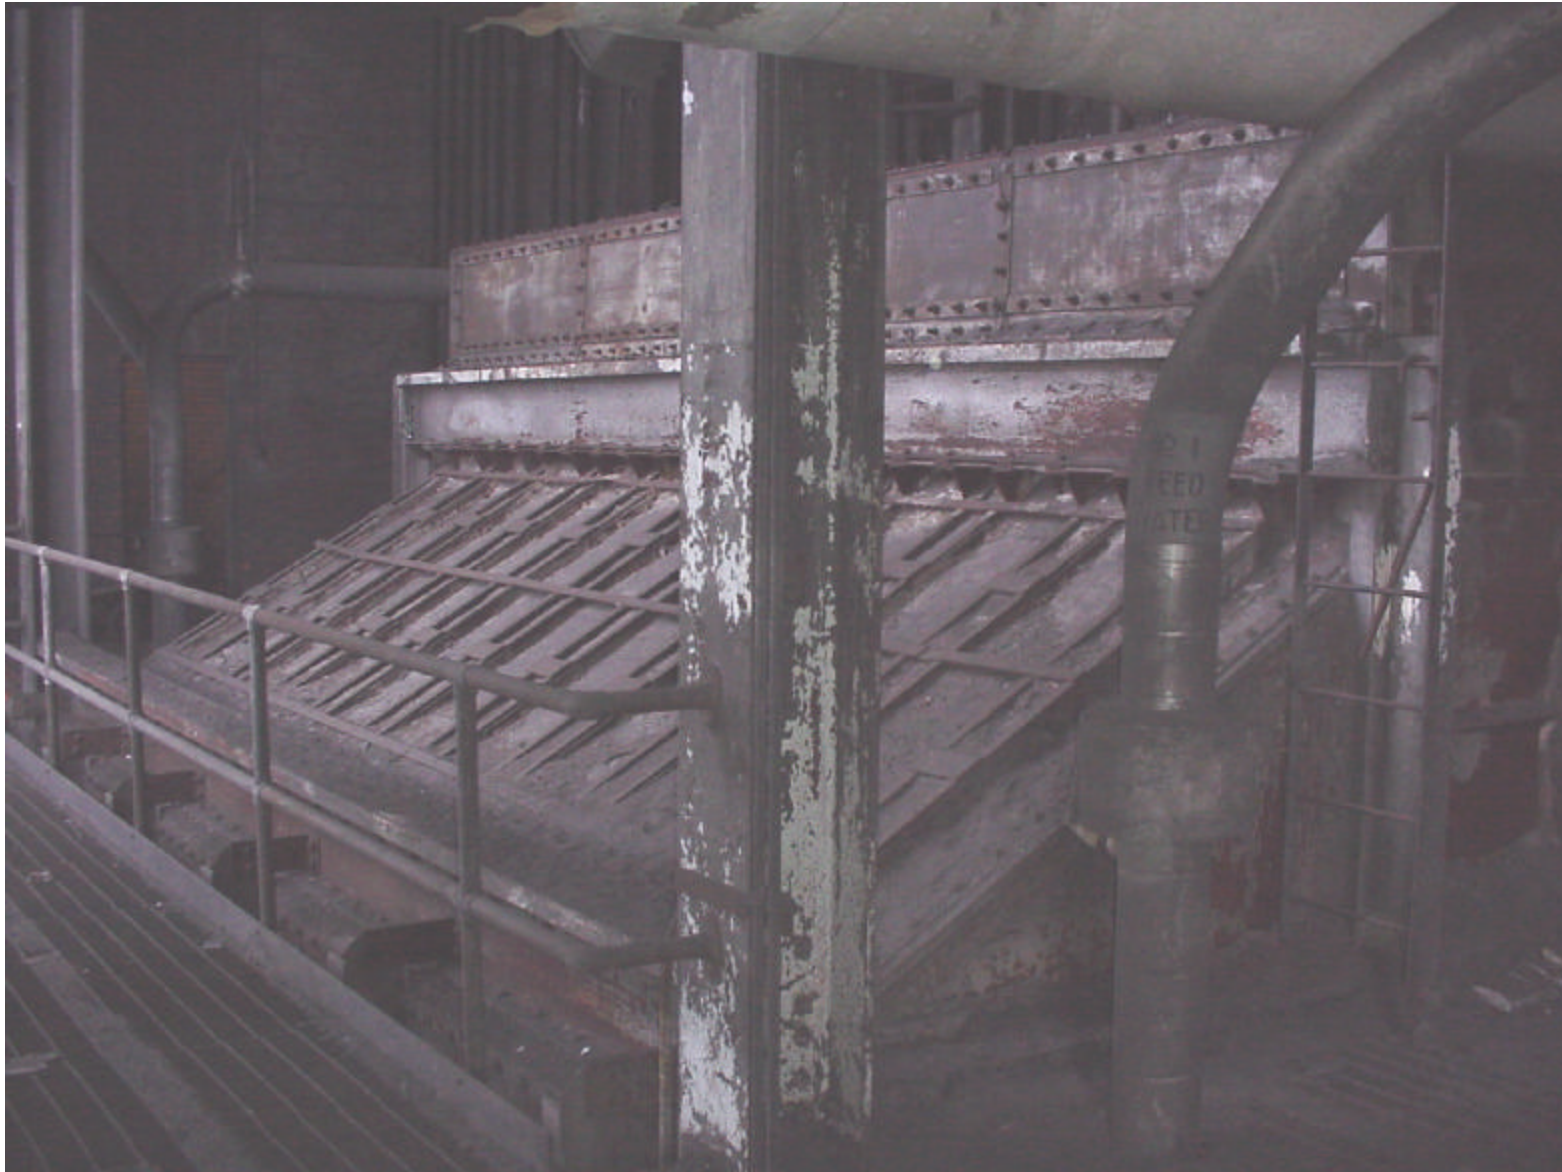
Photograph ID	Date Taken	Section #	Room #	Room Description	Description
MVC-697		VII	7.06G	4nd Floor Boiler House	Boiler unit in northeast corner fo the room

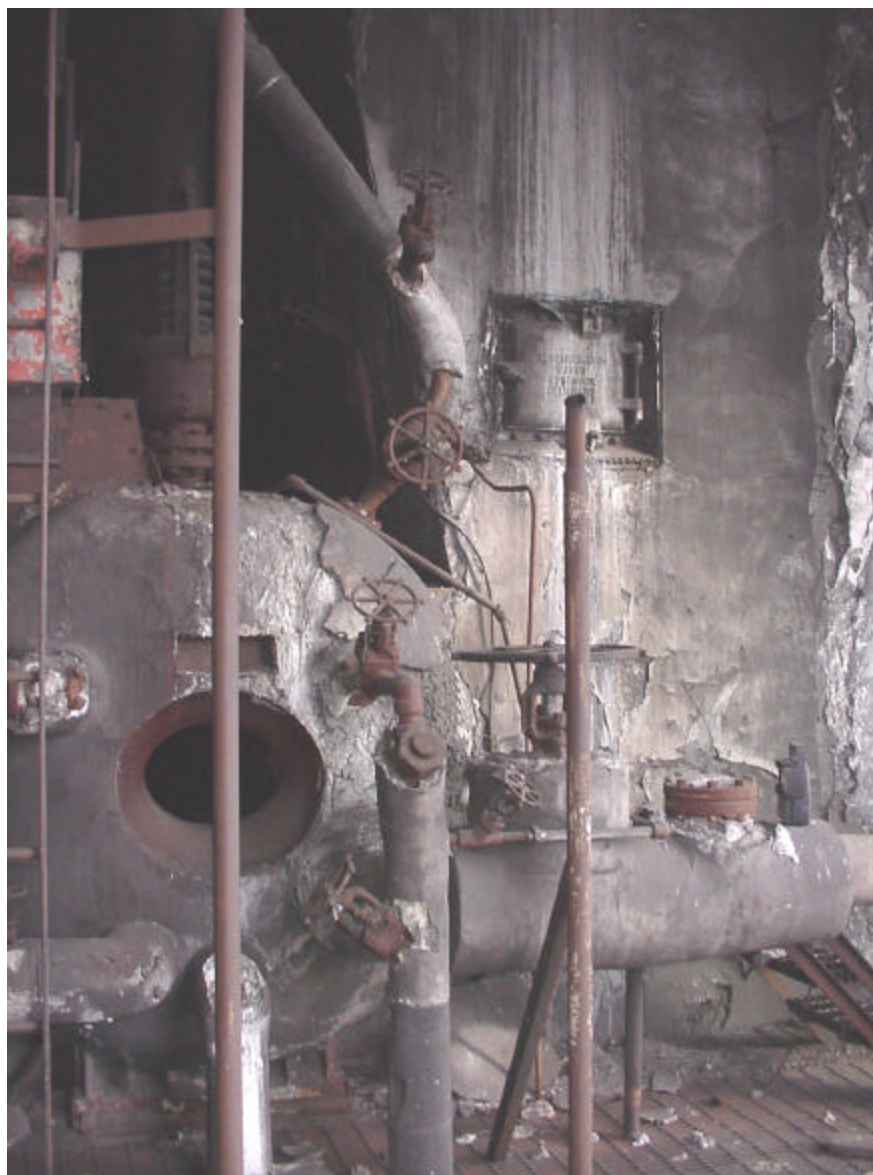
Photograph ID	Date Taken	Section #	Room #	Room Description	Description
MVC-698		VII	7.06G	4nd Floor Boiler House	PACM wrap in southwest corner looking west

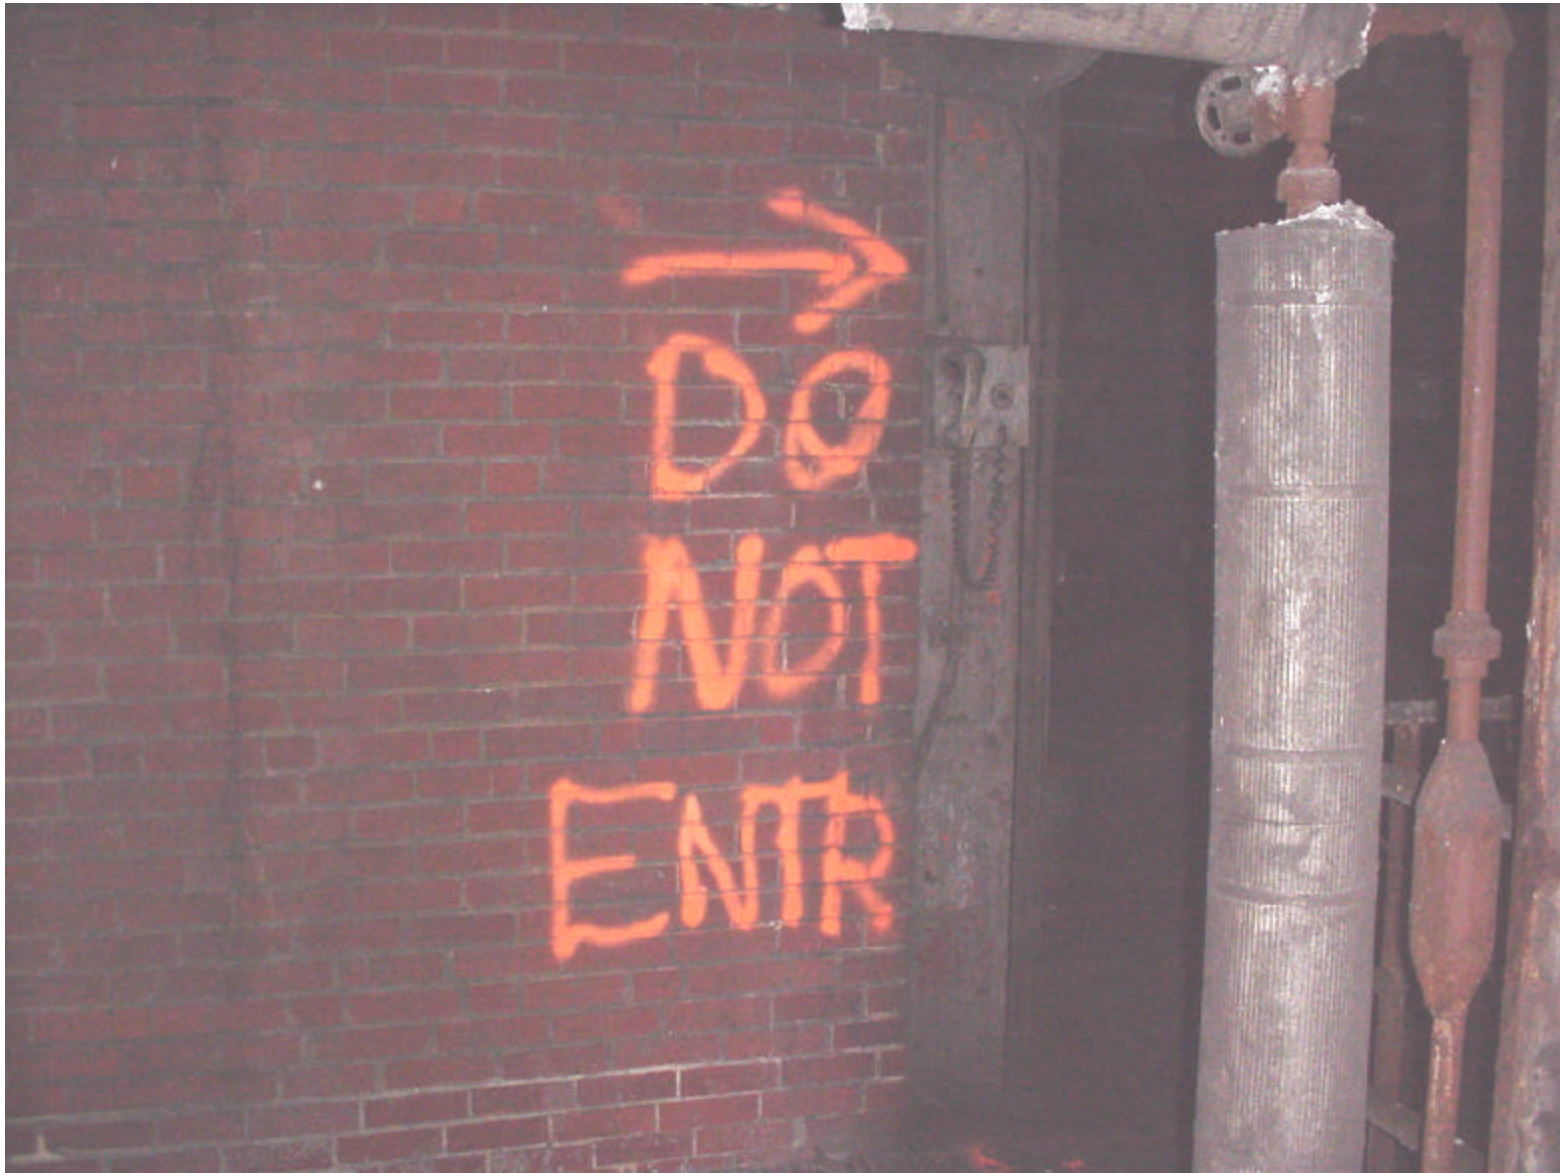
Photograph ID	Date Taken	Section #	Room #	Room Description	Description
MVC-699		VII	7.06G	4nd Floor Boiler House	Warning on wall - Do Not Enter- center of room

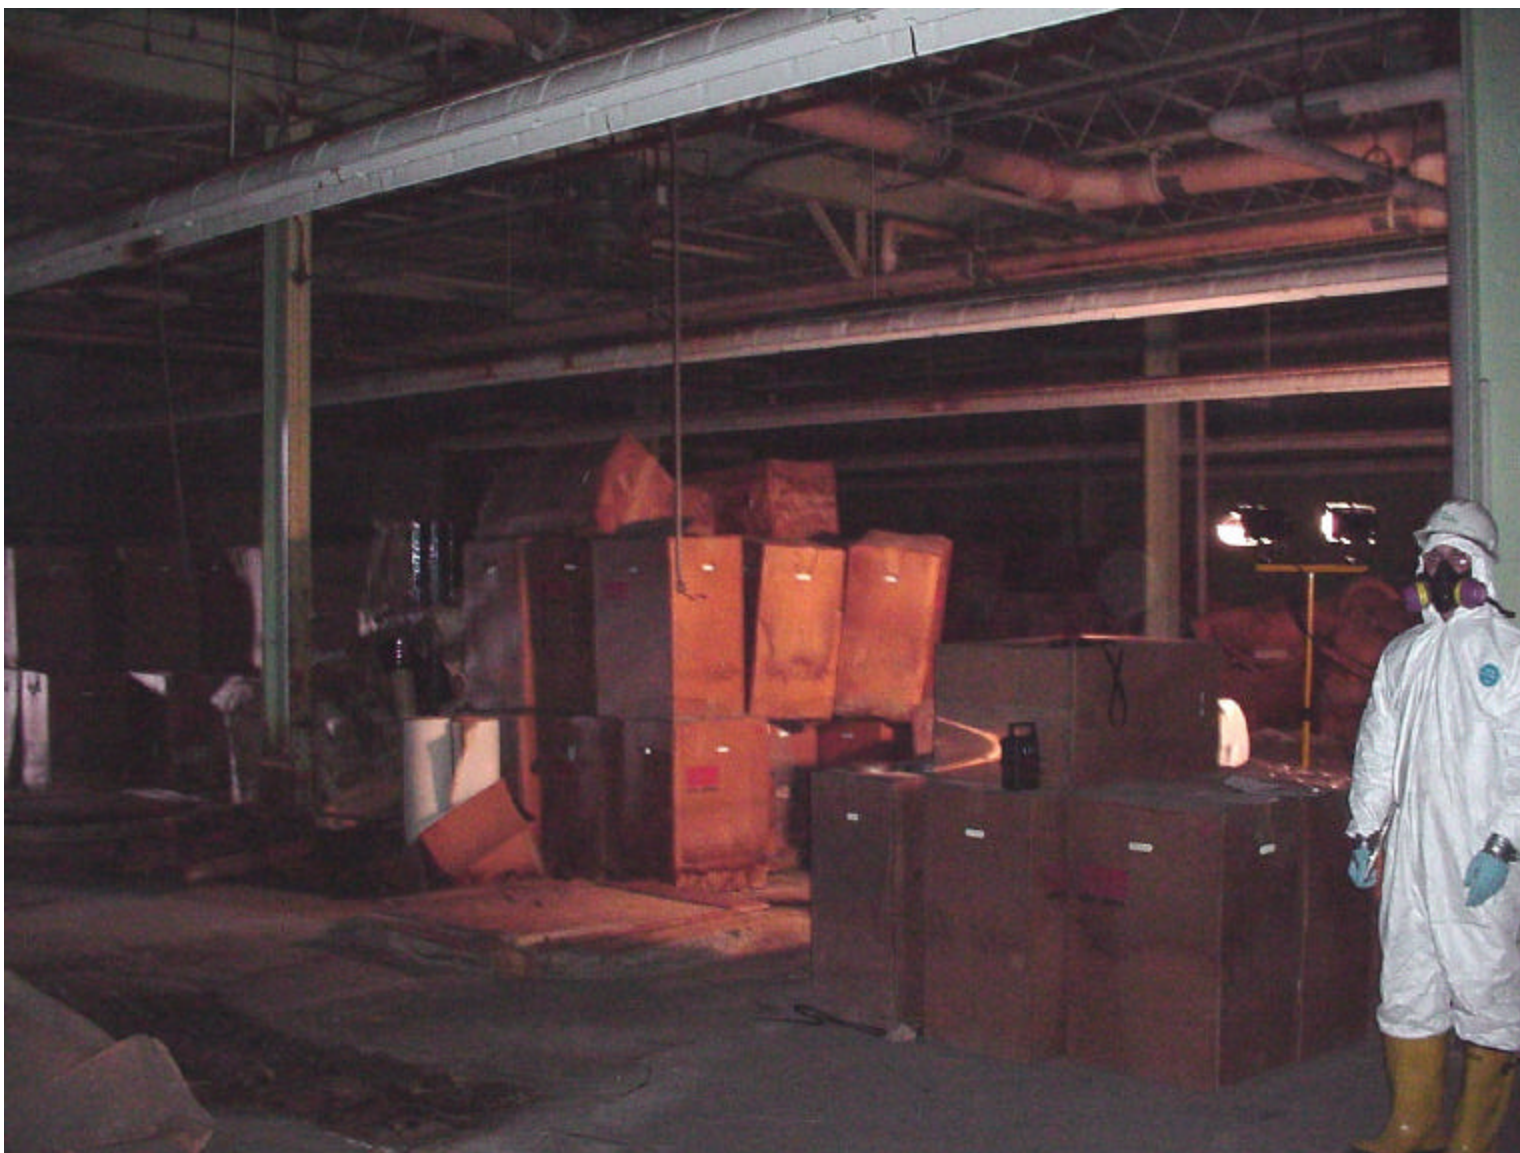
Photograph ID	Date Taken	Section #	Room #	Room Description	Description
MVC-207	11/22/99	I	1.04D	Polyester Spinning 4th Floor	Miscellaneous debris located throughout room.

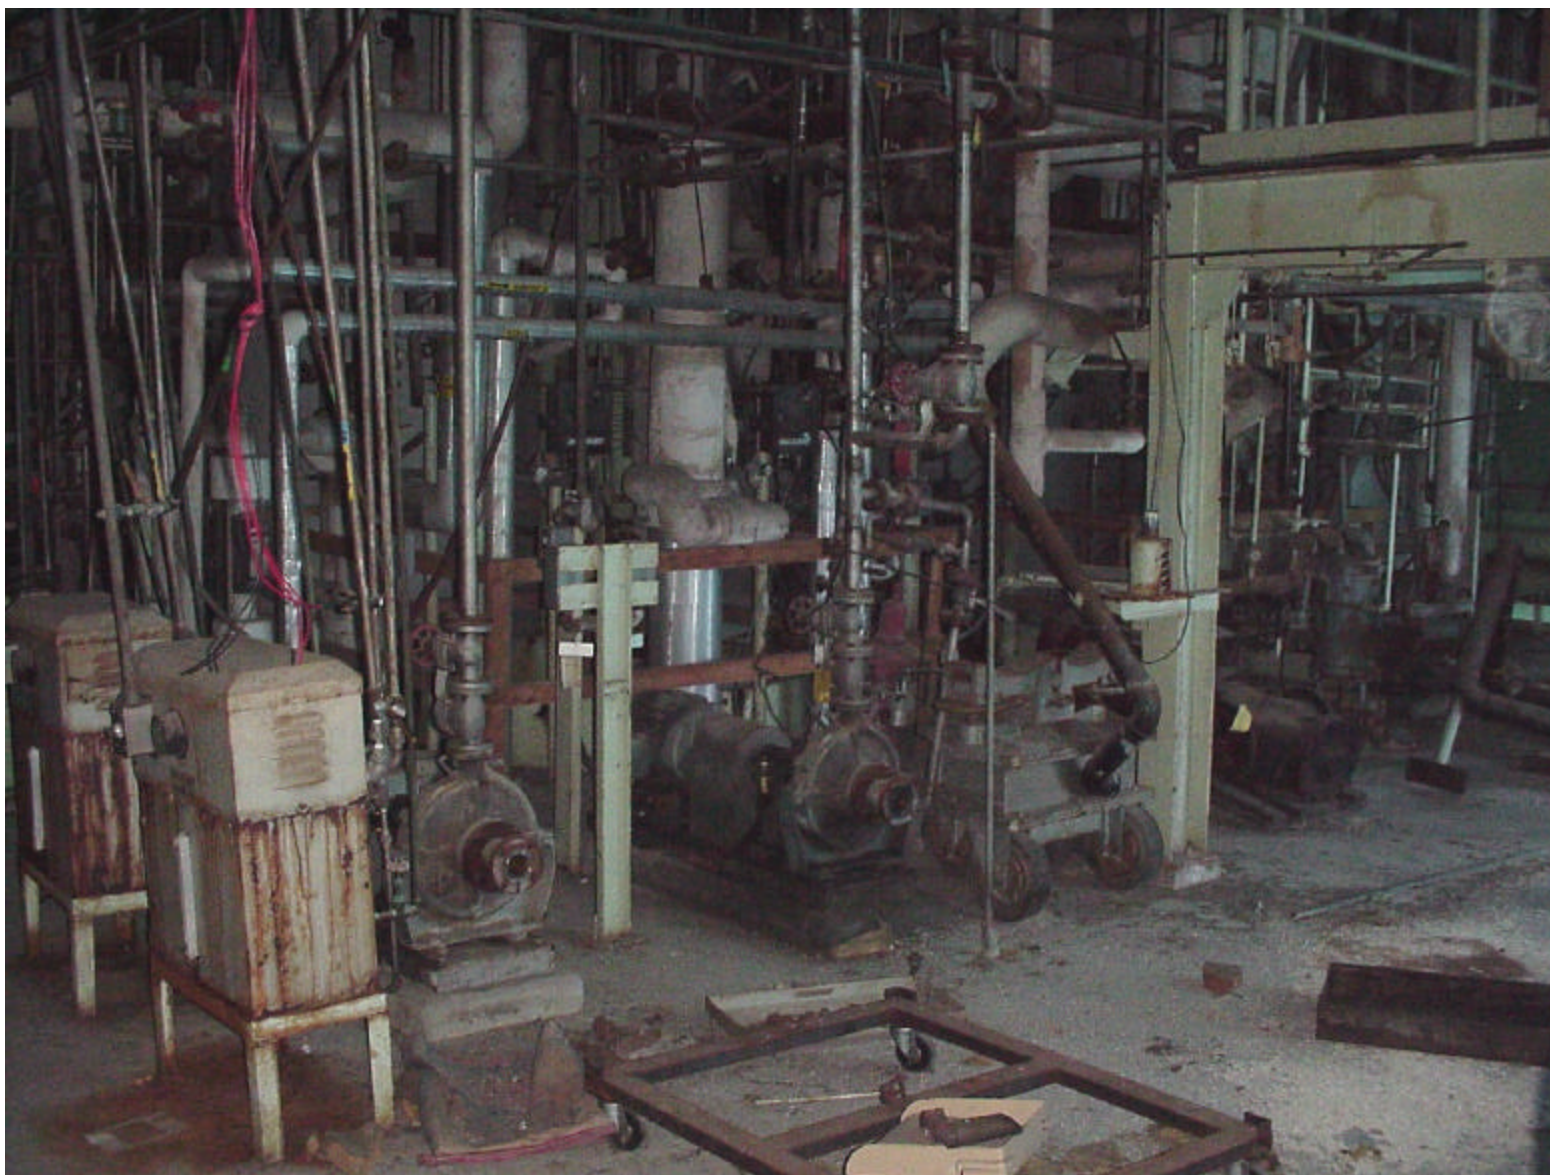
Photograph ID	Date Taken	Section #	Room #	Room Description	Description
MVC-208	11/22/99	I	1.05E	Polymer Plant 4th Floor	Piping and equipment located in room.

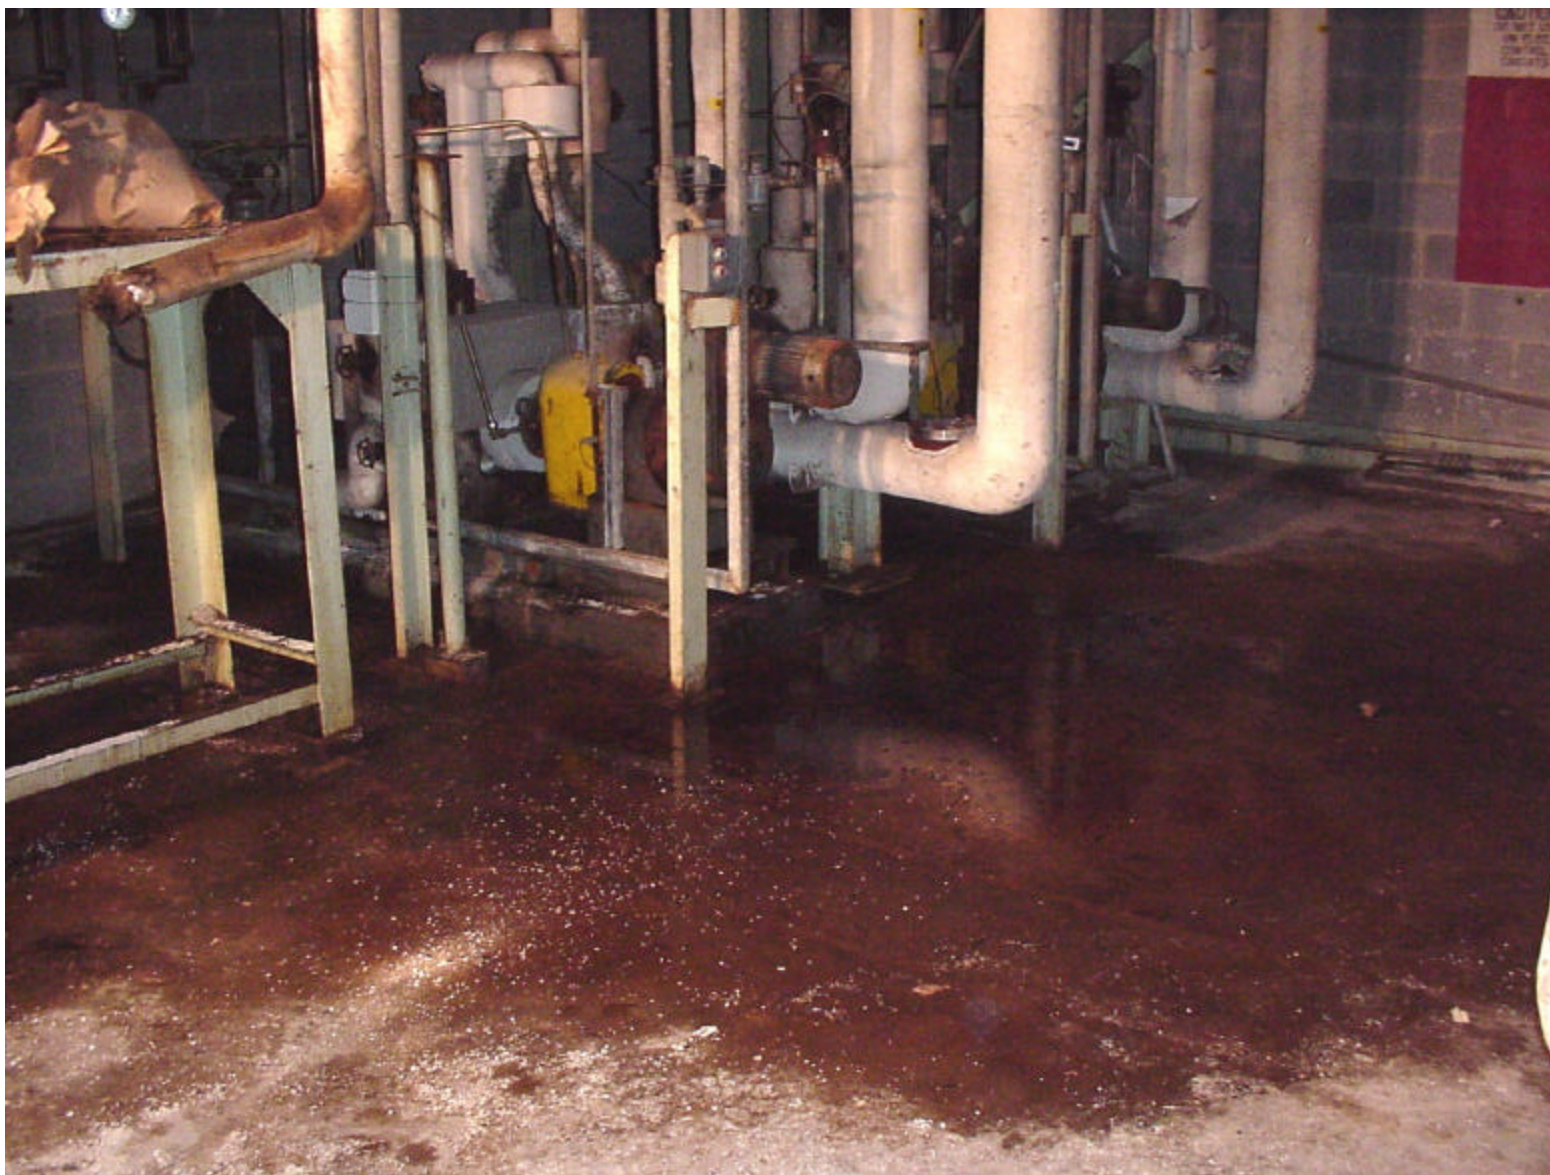
Photograph ID	Date Taken	Section #	Room #	Room Description	Description
MVC-209	11/22/99	I	1.05E	Polymer Plant 4th Floor	Residual oil and oily staining on the floor.

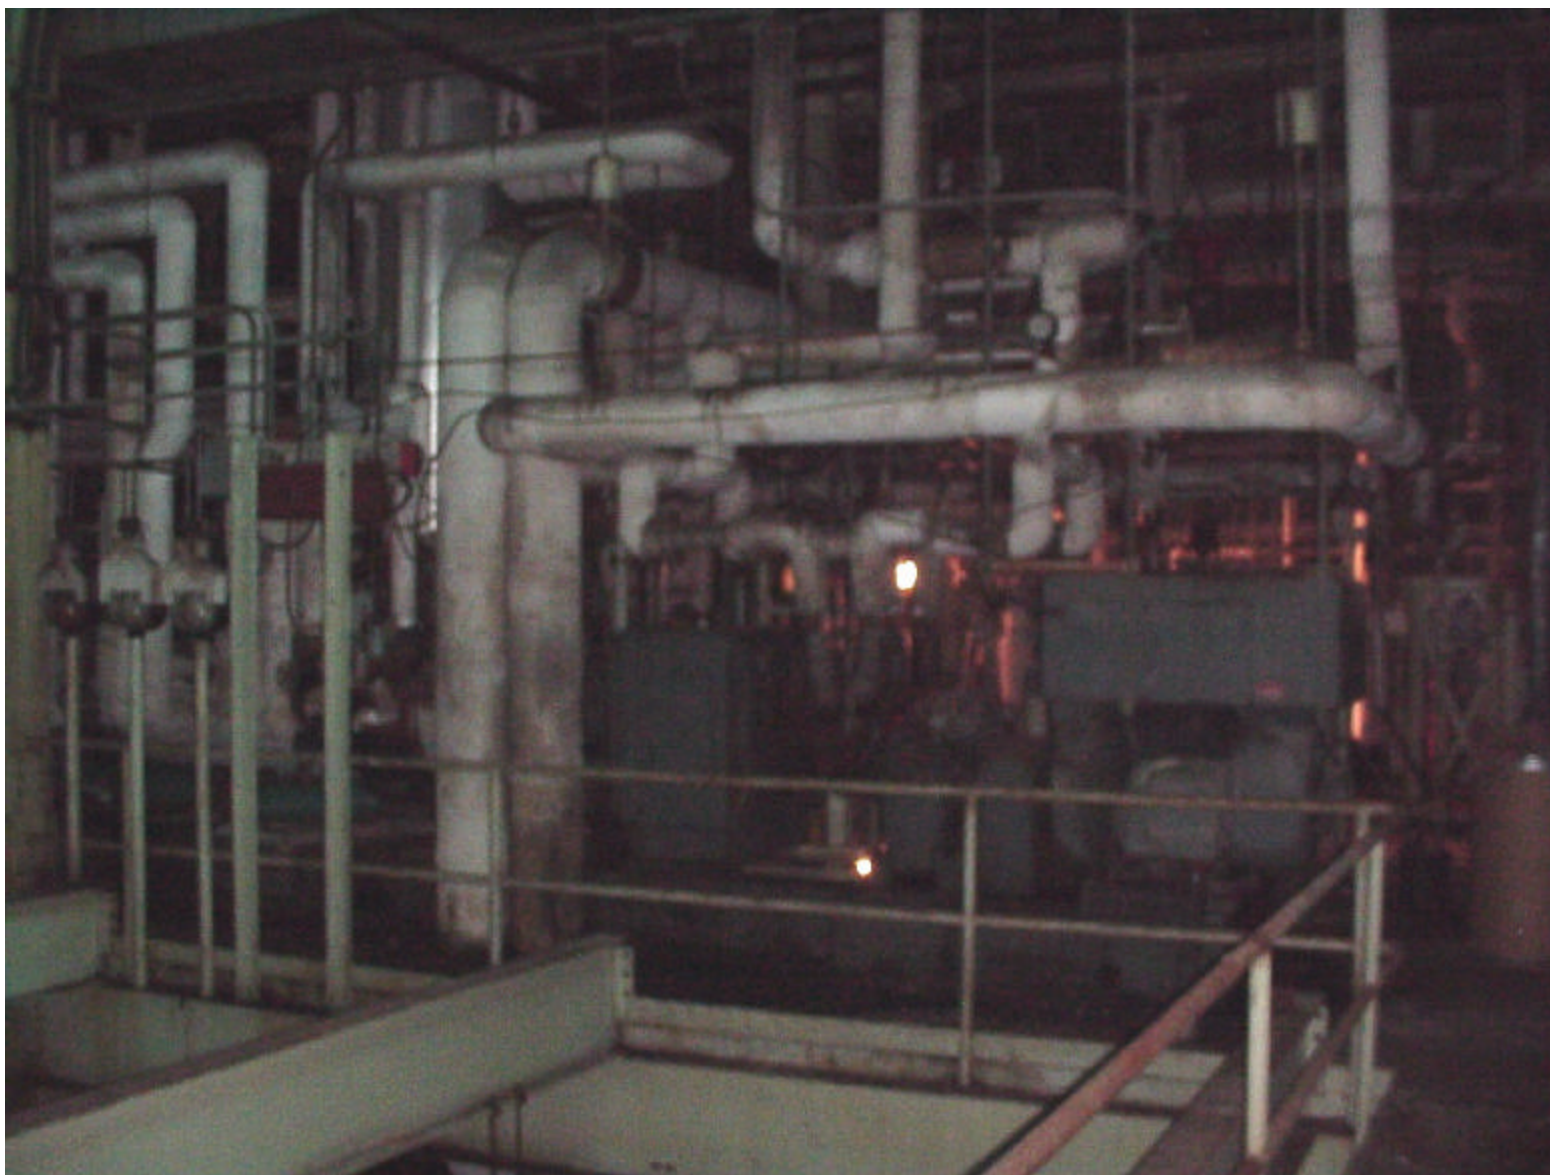
Photograph ID	Date Taken	Section #	Room #	Room Description	Description
MVC-210	11/22/99	I	1.05E	Polymer Plant 4th Floor	PACM pipe insulation located throughout room.
